**TECHNICAL ASSISTANCE TO THE  
PUBLIC WORKS DEPARTMENT  
EDF PROJECT # 9.ACP.VA.02 – PWD MAINTENANCE TRAINING PROJECT**

Site visit report to Malekula

19-21 March 2007

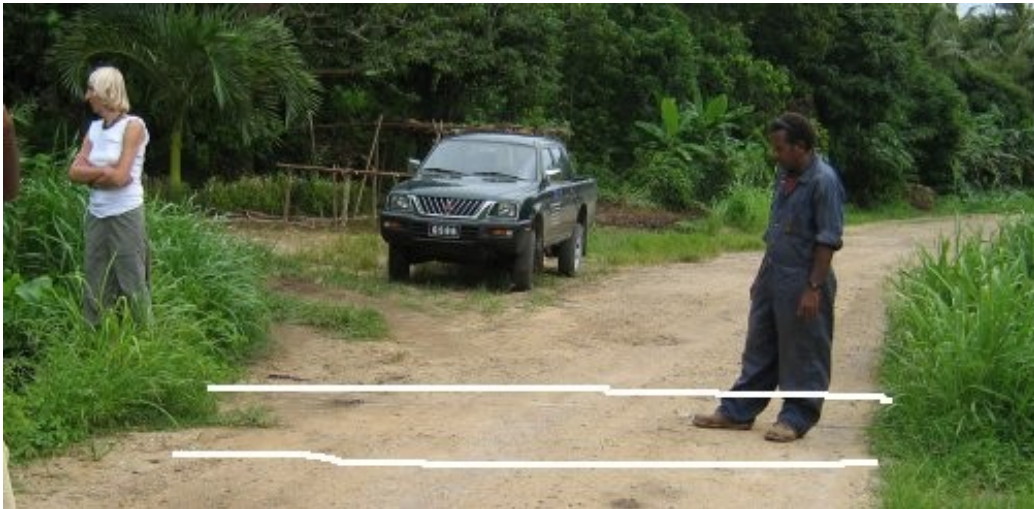
- one cattle grid to be cleaned

*Illustration 2.1.: buried cattle grid*
